Royle House

CT-1297

9740 Old Solomons Island Road, Owings (Calvert County)

# Maryland Historical Trust Maryland Inventory of Historic Properties Form

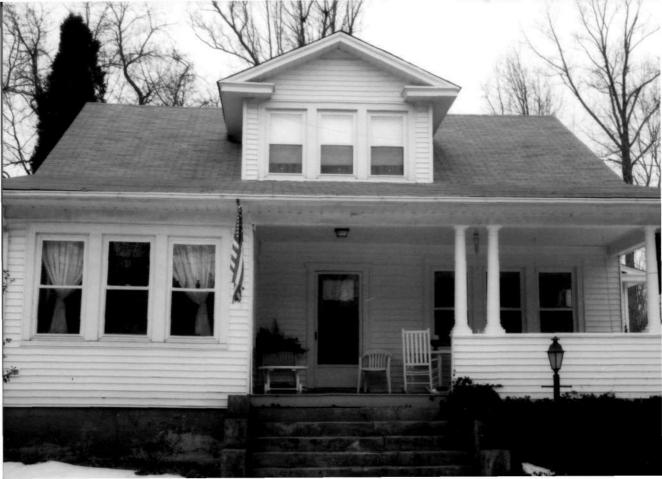
#1 05 6

SOUTH FACADE

The building's south elevation possesses similar fenestration, materials and massing of the north elevation. A small grassy space with a rusticated concrete block retaining wall, set against the elevation, indicates the location of a former driveway. The property also has a small gable-front garage located north of the primary residence. This building is of concrete block construction, and features a gabled roof covered with asphalt

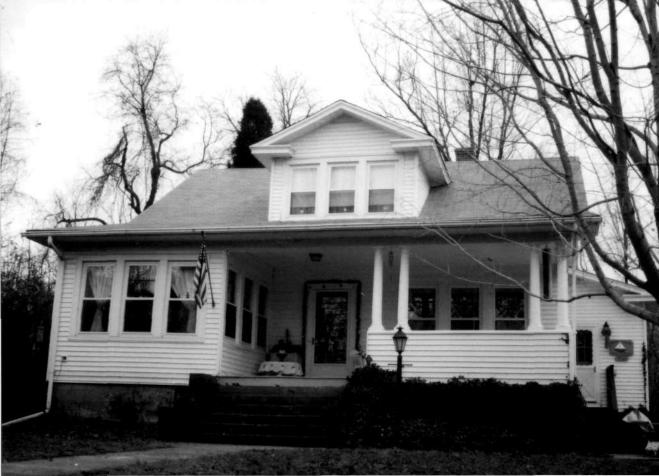
#2 OF 6

CT-1297
ROYLE HOUSE
CALVERT CO., MD
CALVERT CO., MD
CALVERT CO., MD
CALVERT CO., MD
LI/2002
MEJATINE: MD SHPO
SOUTH FACADE

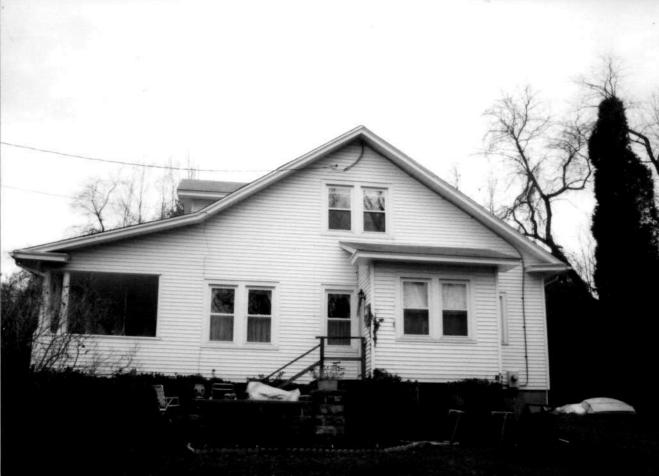
#3086

EAST ENEWATION

The front or eastern façade of the building is distinguished by a moderately pitched roof, which is covered by asphalt shingles and is interrupted by a symmetrically placed gable front dormer. The dormer contains three windows, placed closely together in a symmetrical fashion, and is decorated by overhanging eaves with cornice returns. The first floor of the front façade has a recessed porch, which shelters the building's central entrance. The southern portion of the front porch is enclosed. The enclosed portion of the porch has a band of three windows on the northern and southern walls. The open portion of the porch has a small open wall. The porch roof is supported by two pairs of original wood Tuscan columns. The central entrance is flanked on either side by window openings each containing three sets of windows (which also appeared to have been installed at a later date). The façade is covered with replacement vinyl siding, and the windows are also vinyl replacements (which maintain the original 1/1 sash configuration). The wooden door of the central entrance is partially obscured by a clear storm door. The entrance is reached by a set of concrete steps that lead up to the porch. The façade also displays a concrete block foundation. Obscuring the porch foundation is a row of shrubs and ivy.

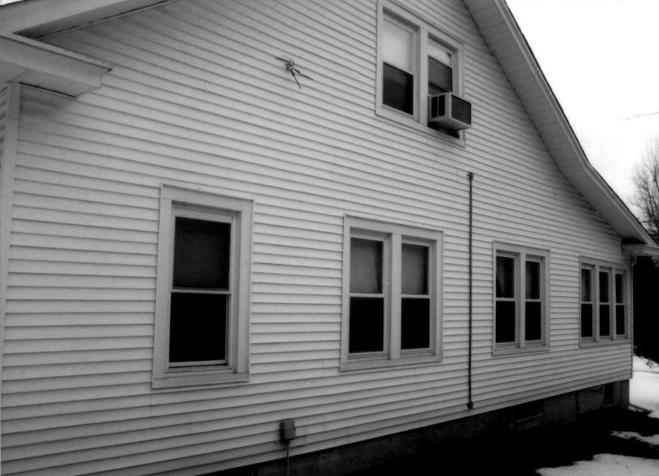
CT-1297 ROYLE HOUSE CALVECT CO, MD CAUSE CHRISTOPHER 11/2002 NEZATIVE MD SHPO WEST EVENATION \$400 G

The west elevation includes a single entrance (paneled wood door with a single pane of glass) set slightly off-center, with an asymmetrical placement of three windows.

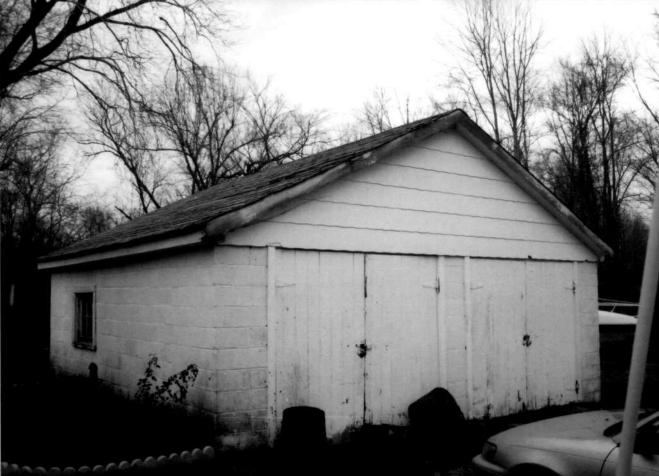
#5 OF 6

WEW OF GARAGE

shingles and two sets of swinging wooden garage doors. The extant foundation of another garage building, which was converted into medical office by Dr. Hugh Ward, is located directly southwest of the residence.

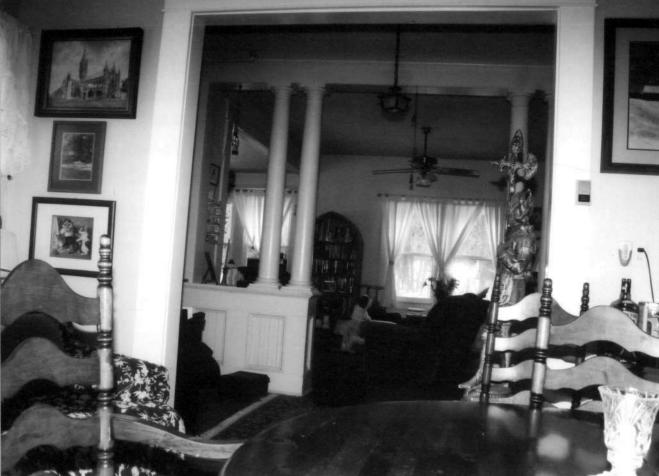
CT-1297 ROYLE HOUSE CALUERT CO. MD CALOS CHRISTOPHER 11/2002 NEGATIVE: MD SHIPO INTERIOR - LIVING DINNY ROOM # 6 OF 6 65940

To the north of the entryway, an open entry with wood trim opens up into a dining room space, which has a full length glass door and closet in the southwestern corner of the room. The dining room also retains its simple wood trim on the ceiling corners. The dining room opens up through a wooden door into the kitchen, which has linoleum flooring, and a tongue-and-groove covered cabinet. Adjoining the kitchen is a small mud room, which is located on the north side of the building and is connected to a narrow corridor. This corridor opens into a small bathroom (which is original to the building) on the west, and into a narrow stairway on the east. Beyond an exterior entrance on the western façade, the corridor opens into a newly renovated bathroom (formerly the medical office's waiting room). At the building's primary entrance on the south, the corridor opens into a small bedroom (formerly the medical office's examining room). A narrow set of stairs leads to a small open corridor on the second floor, which opens up directly into a small bedroom space set within the exterior dormer. The hallway leads on the north and south to bedrooms, which are connected by a narrow hallway and renovated bathroom on the western portion of the floor, newly added in what was a wood closet. Walls along the east and west side of the upper story are angled toward the ceiling due to the building's low roofline, and the ceilings are lower than those on the first floor. No wood trim was found in the building's upper story.
